## EDIPHYTES OF KARACHI

*Ediphytes* or “Building plants” are vascular plants growing out from the moist wall crevices and cracks caused by leaking sewage pipes of the neglected and dilapidated, multi storeyed buildings. *Ediphytes* have adapted themselves to live in the stress condition of crevices, their seeds are mostly inconspicuous and can reach the seed banks of the building material or through the rain or wind. They can also reach the crevices through biotic agents such as insects, birds, bats, rodents or human beings. The *Ediphytes* can cause cracks and damage to the facade of the building. A survey of ediphytic trees including woody climbers and herbs of Karachi was conducted during the years 2008-09 in the five districts of Karachi, covering 1000 ediphytic plants belonging to 17 families and 25 species, most of the *Ediphytes* belong to trees of family *Moraceae* (genus *Ficus*). Among them most common species is *Ficus rumphii*. The herbaceous *Ediphytes* include eleven species belonging to eight families; majority of herbaceous *Ediphytes* belong to family *Poaceae*. *Ediphytes* can prove to be dangerous for buildings so ways and means should be developed to remove the

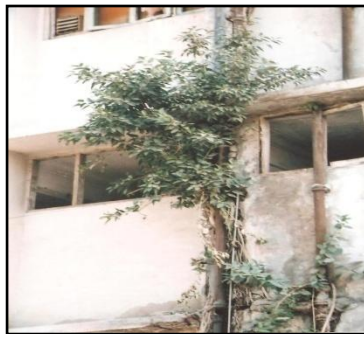
Fig.2. *Ficus rumphii* Blume growing from a crack of the Adamjee Govt. Sci. College caused by a leaking sewage pipe.

Authorities in Karachi Building Control City District Government and other authorities should look into the menace of Ediphytes seriously and should not consider these plants as sacred or venerable. Instead the general public, contractors, builders and civil engineers should take care of the dripping pipes, damage sewage system, crevices and cracks present in the buildings and the Ediphytes sprouting from there should be removed otherwise with the passage of time they will topple down the whole structures to rubbles.

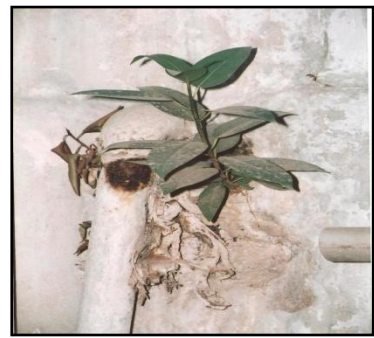
Fig.3. *Ficus rumphii* Blume is propping from the crevices of the Adamjee G.S.C. building near the damaged sewage line.

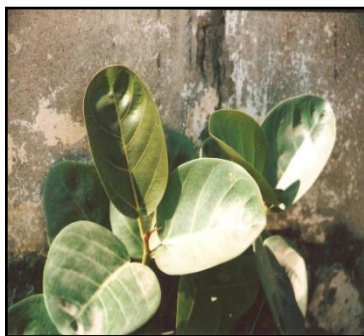
Fig.7. *Ficus bengalensis* L. (Burgad) growing near leaking sewage line. Islamia College building.

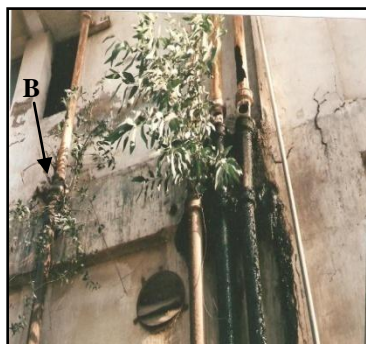
Fig.10. A. *Eucalyptus citriodora* Hook left and B. *Salvadora persica* L. (Peelu) right, growing from the damaged leaking sewage pipe of a Govt. office building, Gulshan-e-Iqbal.

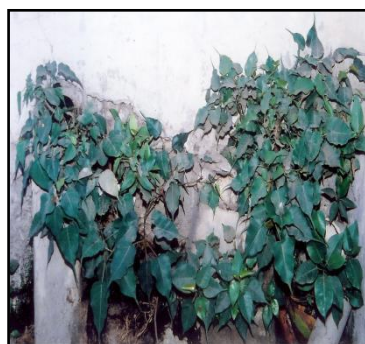
Fig.11. *Ficus religiosa* L. (Pipal) growing from a leaking and damaged sewage line of Islamia College building.

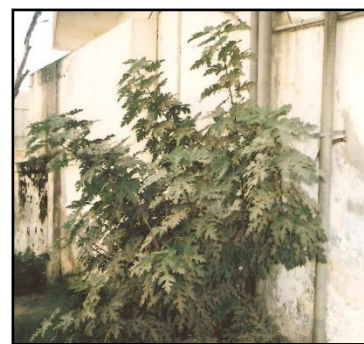
Fig.12. *Ficus johannis* Boiss growing from the damaged sewage line of a residential building.

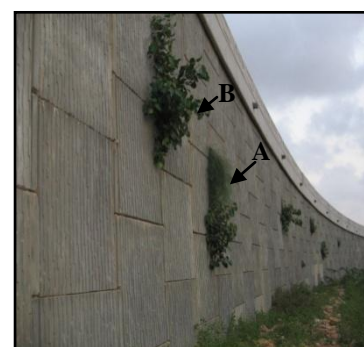
Fig.15. Group of ediphytes growing from the ramp crevices of newly constructed Lyari Express Way Ramp A-B = refer to Fig.14.

These Ediphytes have not only occupied the crevices and cracks of neglected or hamshackled buildings but they even invaded the crevices of the newly build Lyari Express Way in Karachi.
